FHAD MODEL COMMENTS – SUBMITTAL 2 MEETING MINUTES

Brantner Gulch MDP and FHAD Thursday, July 21, 2022 11:00 am via Microsoft Teams

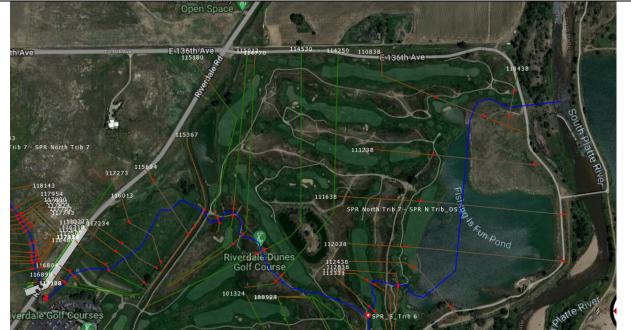
21	7	General Comments - Word Doc	In SPR North Tributary 7 from downstream of Riverdale Rd to the confluence with South Platte River, our detailed review revealed the following issues: • XS 114250, 114530, 115694 and 116899 in the reach of SPR N Trib 7 and XS 110438, 110838, and 111238 in the reach of SPR N Trib_DS, the end points do not contain all events. Please expand or adjust alignment to fully contain all events. • The current modeling configuration is very complicated and substantially increases the challenges for arranging all elements appropriately. Since this reach is located within the golf course, a simplified modeling approach only emphasizes the critical controls that might facilitate the model setup and still provides reasonable hydraulics in this reach.
	1

Discuss modeling approach. Per the report: A total of four cross sections are unbound on the SPRN North Tributary 7 reach in the golf course (Cross Sections 114250, 114530, 115694, and 116899). Flows will generally follow the main alignment through this reach, but will find other overland paths through the golf course as well. The golf course area is modeled as ineffective flow area in the 1D model. The desired modeling approach in this area will be discussed after the next review to determine if modeling changes are needed and discuss the approach for the unbound cross sections if the modeling approach does not change.

Notes: Look to try and eliminate some of the cross sections and try and simplify the model. Remove non-controlling sections. Perhaps focus on high grounds and contain them, then focus on the mapping. 400 feet is more of a District requirement, and not necessary in this instance. The profile will be referenced to determine which cross sections can be removed without impacting water surface elevations.
